INTERIOR TRIM AREA

Interior Trim Area

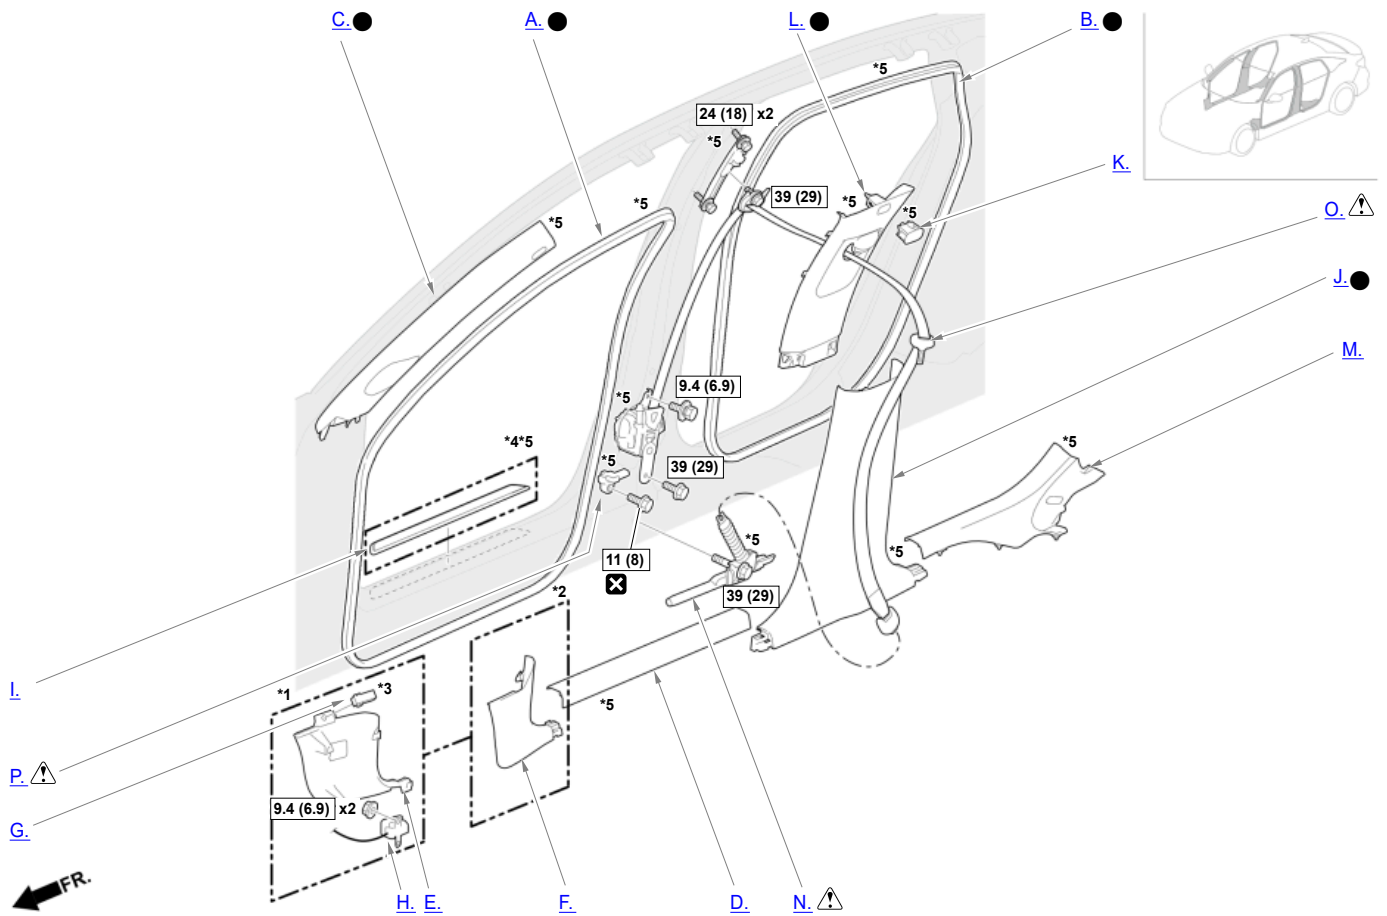
1

*1: Driver's side
 *2: Passenger's side
 *3: With driver's footwell light
 *4: With front side outer trim
 *5: Part(s) are shown for one side only as the procedure is the same for both sides.

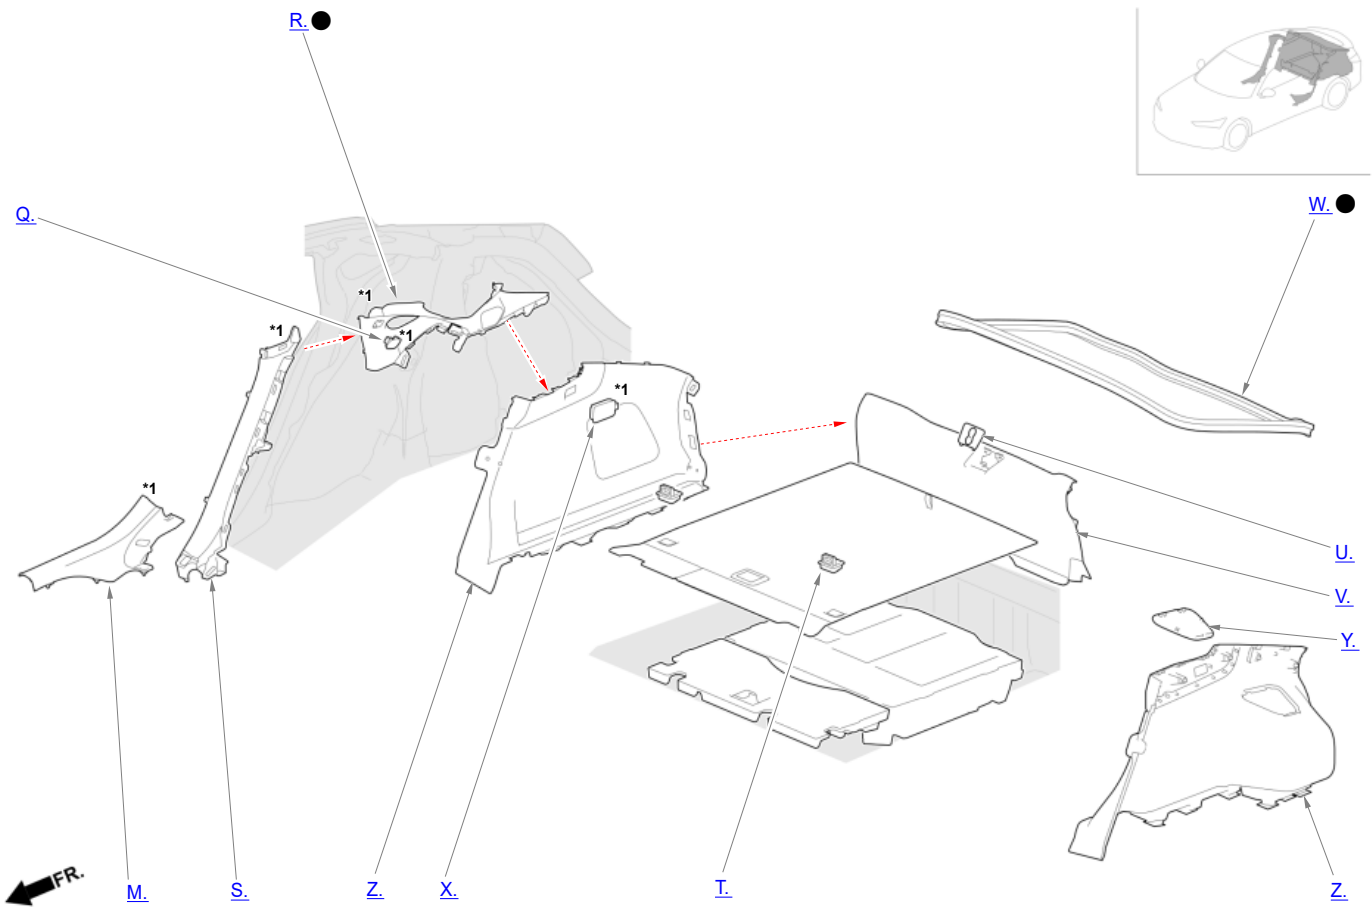
2

*1: Part(s) are shown for one side only as the procedure is the same for both sides.

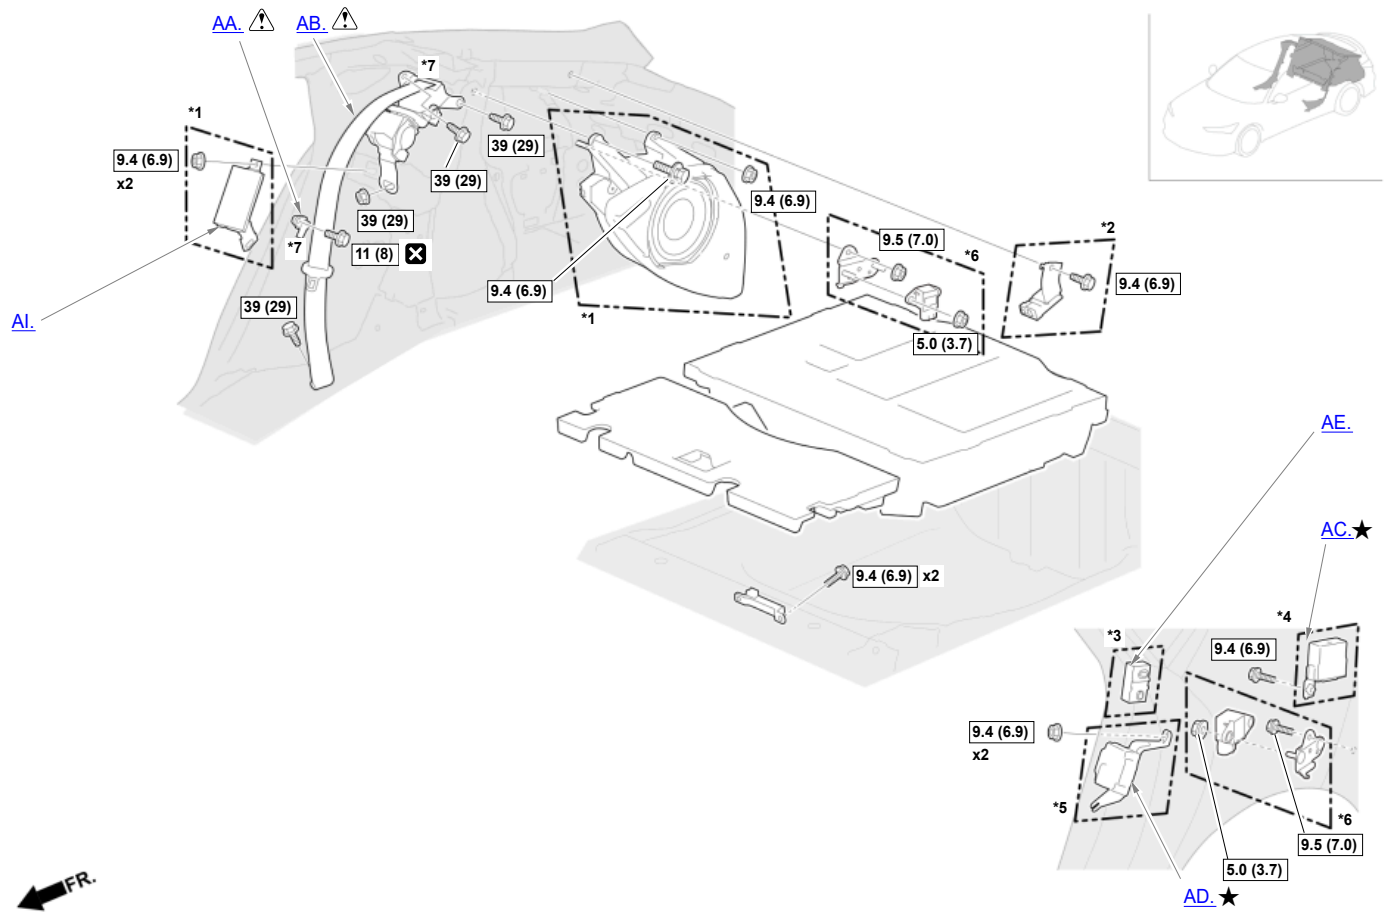
3

- *1: Display audio type (9-inch screen)
- *2: With 2-way transceiver
- *3: With rear seat heater control unit
- *4: With parking and back-up sensor control unit
- *5: With adaptive damper system
- *6: Type-S
- *7: Part(s) are shown for one side only as the procedure is the same for both sides.

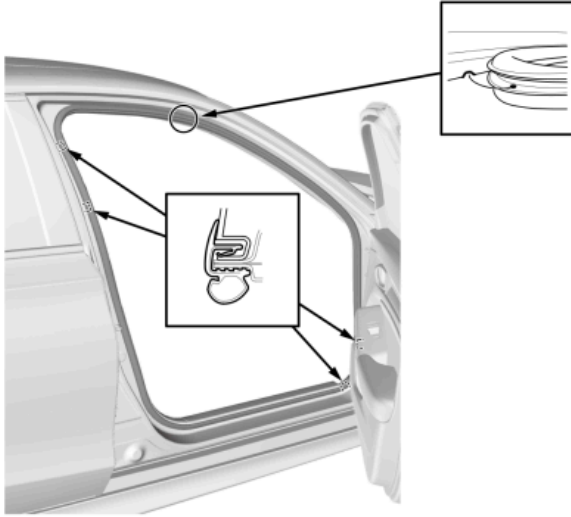
A. -

- Refer to the figure.

- Water Leaks Check

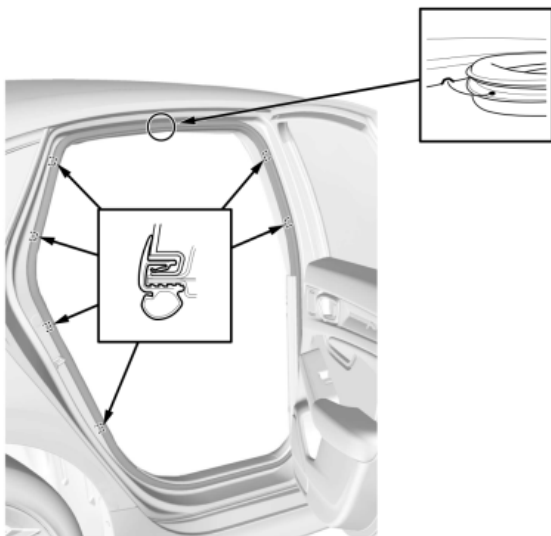
B. -

- Refer to the figure.

- Water Leaks Check

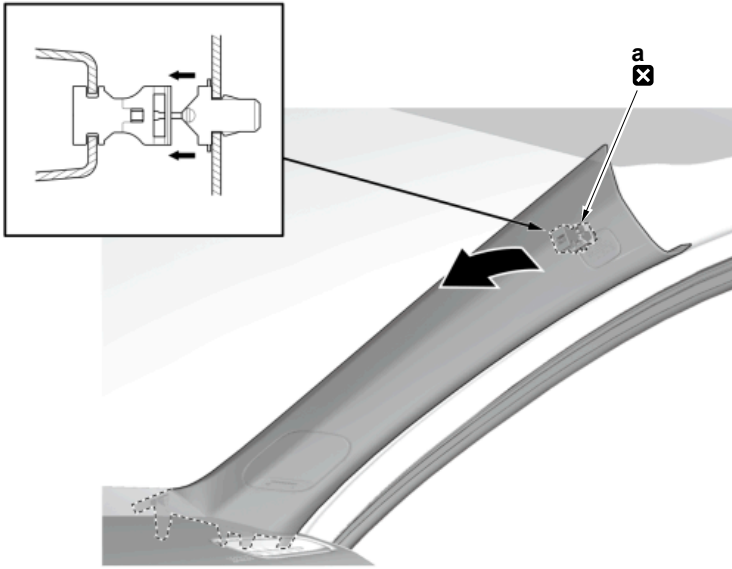
Figure 1

- Refer to figure 1, 2, and 3.

- Replace the upper clip (a) with a new one.
- The clips will stay in the body.

- Before installing the A-pillar trim, install the clips to the A-pillar trim.
- After inspecting the A-pillar trim, install the A-pillar trim.

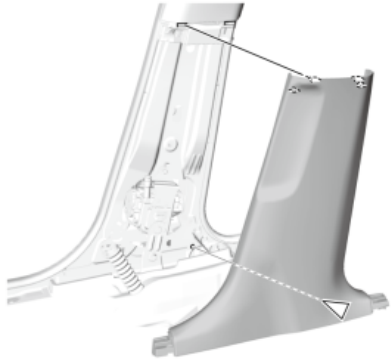
J. -

- Refer to the figure.

- After inspecting the B-pillar lower trim then, install the B-pillar lower trim.

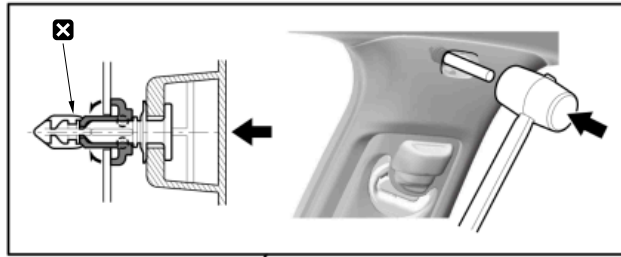
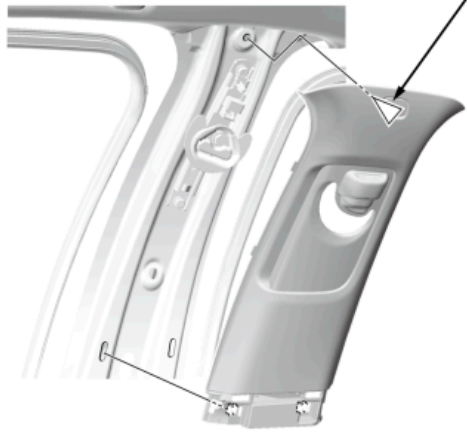
L. -

- Refer to the figure.

1. Replace the upper clip (a) with a new one.
2. After inspecting the B-pillar upper trim then, install the B-pillar upper trim.

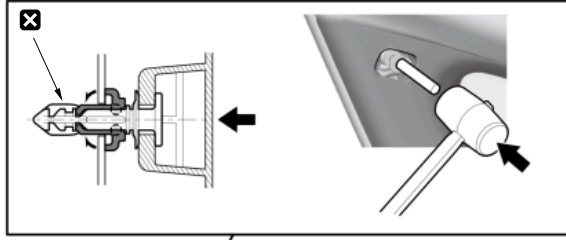
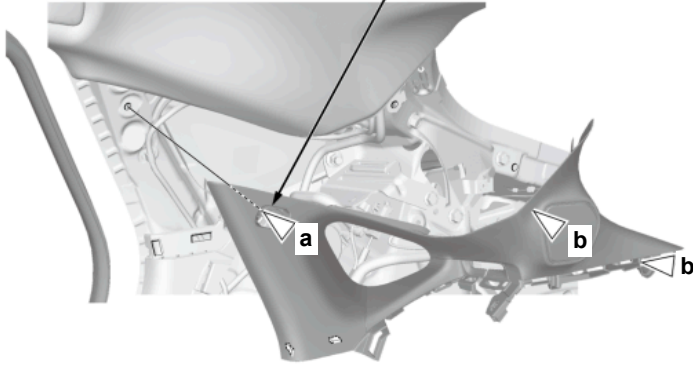
R.-

- Refer to the figure.

1. Replace the upper clip (a) with a new one.
2. After inspecting the C-pillar trim, then install the C-pillar trim.

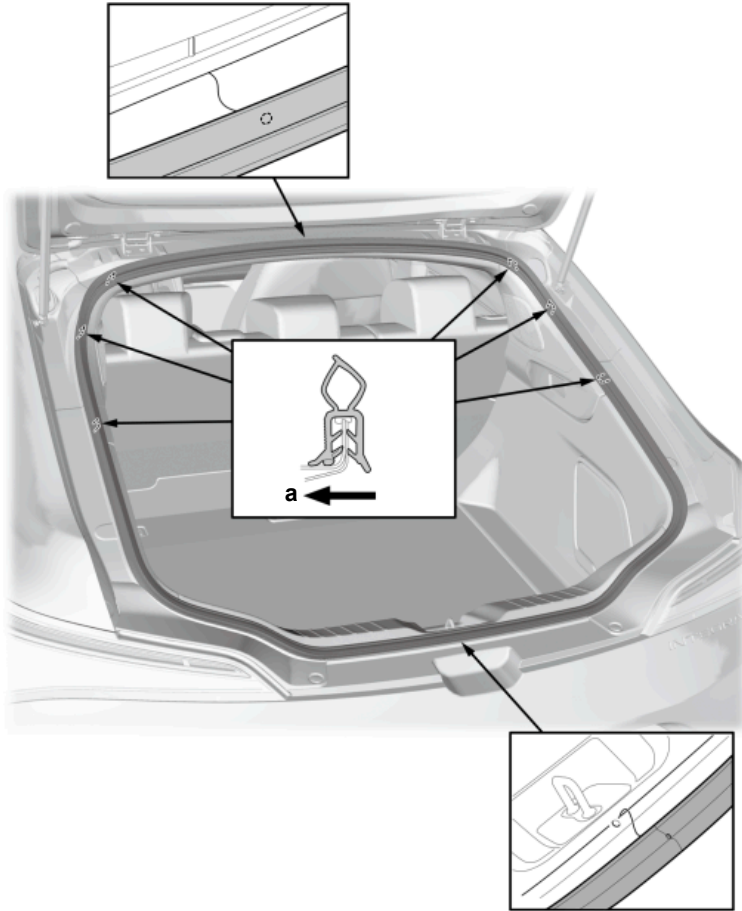
W.-

- Refer to the figure.

Installation Directions

Position	Direction
a	Out side

- Water Leaks Check

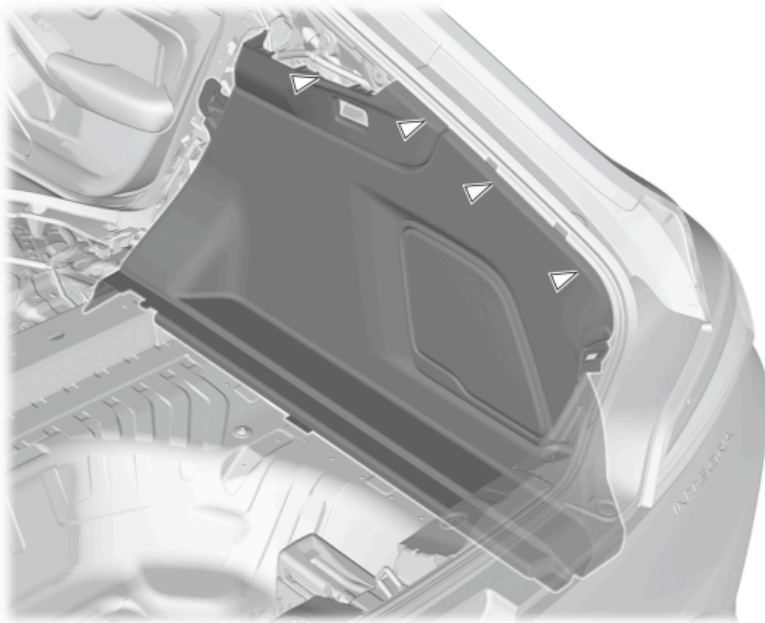
Z.-

- Rear Seat-Back Folded Down

- Refer to the figure.

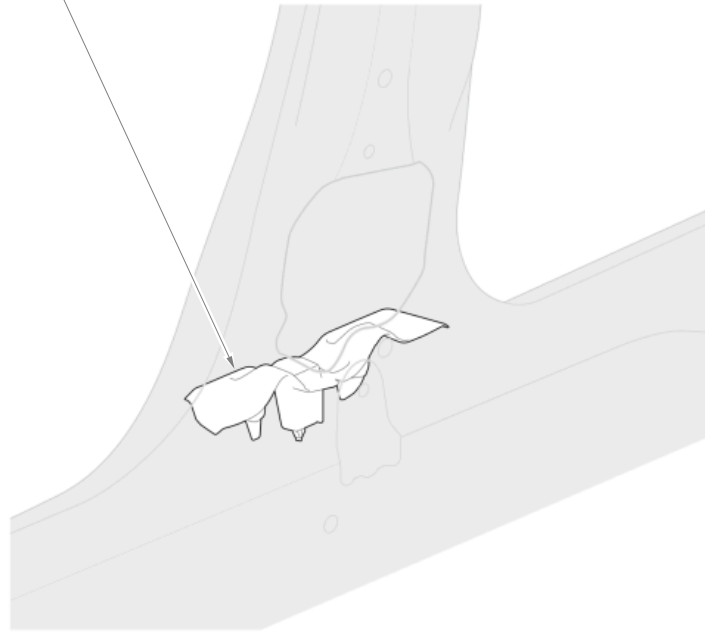
46.

1. A-Pillar Trim

2. **Front Door** Opening Seal

5. B-Pillar Upper Trim

8. Rear Door Sill Trim

9. B-Pillar Lower Trim

17. C-Pillar Trim
